# Manhole Inspection Summary

Manhole # S21KK\_025MH

Insp Date: **9/30/08 8:58 AM**

**Location** Address: **PENNSYLVANIA-NORTH ALLEY** Cross Street: **RETREAT ST**

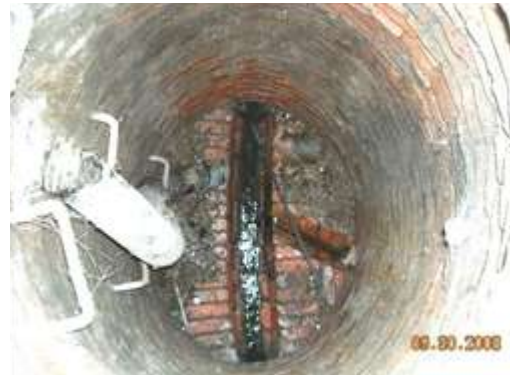
Top View

Bench debris.

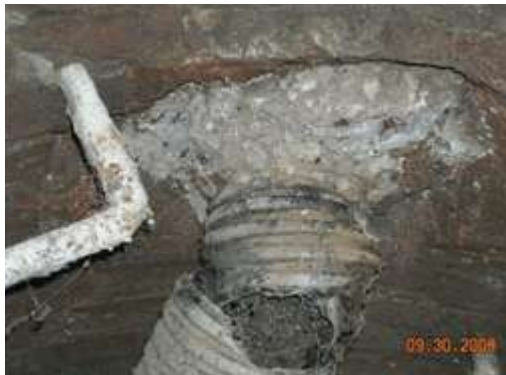
Illicit Connection

CORRIGATED PIPE INTRUSION @ 9 O'CLOCK MEASUREMENT ROD ONLY TO TOP OF INTRUSION: 3.11(ft.)

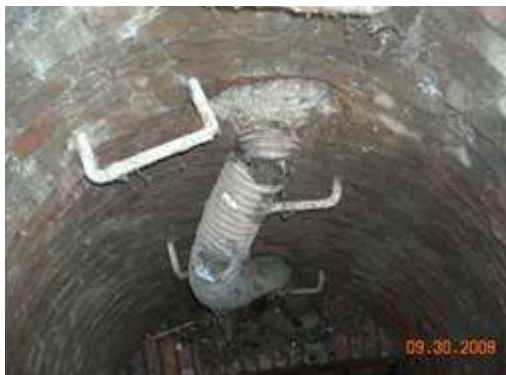
Defect

Adjustment, Corbel and Barrel infiltration.

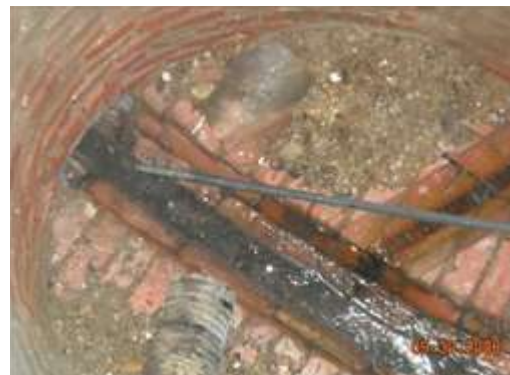
Defect

DEBRIS IN CHANNEL

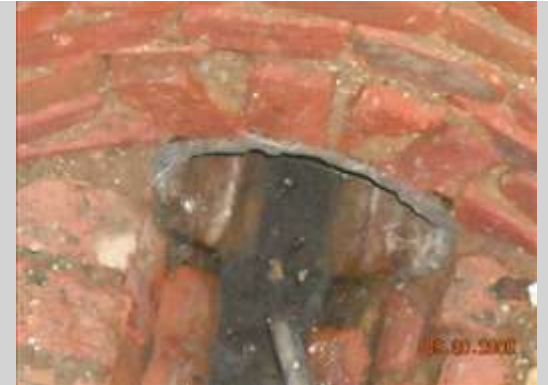
### 8 in. Circular Gravity Sewer Pipe Out @ 12 O'Clock

Infiltration: **Evidence** Pipe Seal Cond: **Unknown**

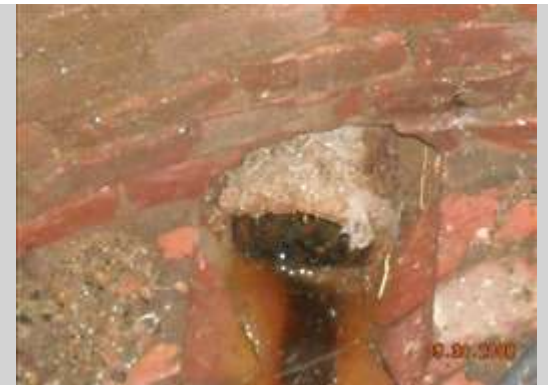
### 4 in. Circular Gravity Sewer Pipe In @ 4 O'Clock

Infiltration: **Evidence** Pipe Seal Cond: **Roots**

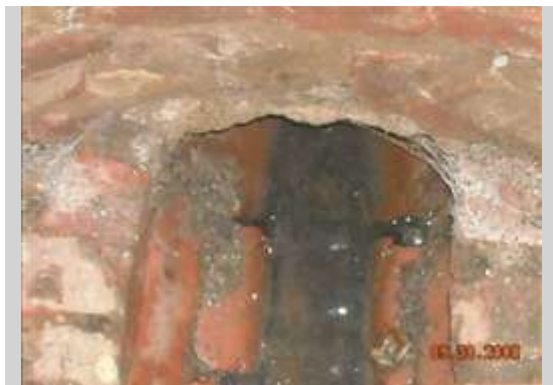
Pipe In @ 6 O'Clock

Infiltration: **Evidence**

Pipe Seal Cond: **Broken**
